## MUGHAL GARDENS IN THE CITY OF LAHORE – A CASE STUDY OF SHALIMAR GARDEN

S. Mubin\*, I.A.Gilani\*\* and W. Hasan\*\*\*

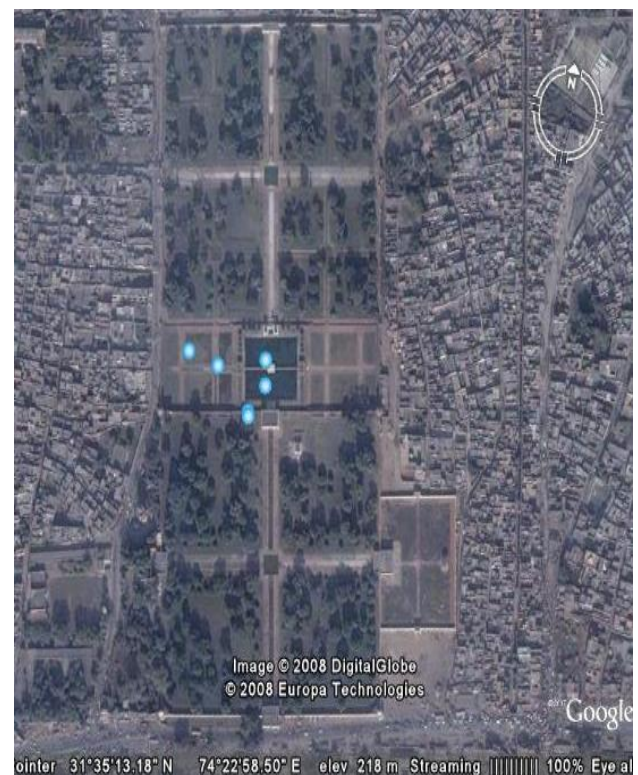
**Figure – 7: A satellite image of Shalimar garden taken on 17-02-2008, showing massive development in the surroundings of Shalimar garden**

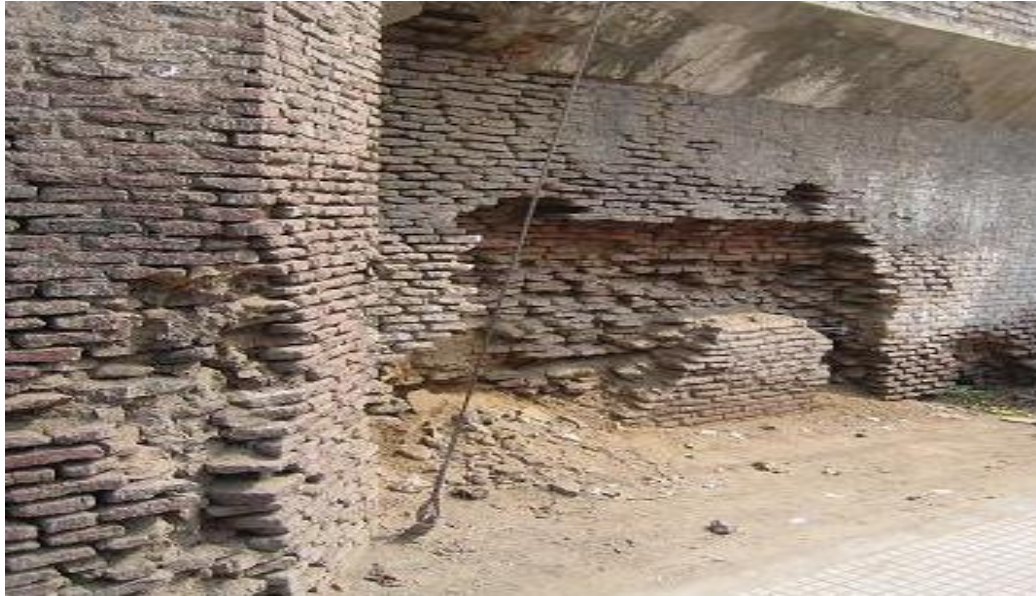
The northern and the Eastern walls are in the much worse conditions than the other two walls. The renovation progress seen on site was thoroughly studied and found to be unsatisfactory and seems to be the absence of concerned skills and expertise in relevant field. Most of the old structures, especially floors are being replaced with new floors instead of preservation, which is un ethical in preservation of such a great monument Northern main gate of the garden is also removed, while huge garbage may be seen around the wall (figure 11). Drain water is one of the major reasons of the decays of the wall foundation, which can be seen from figure 8 that super structure is in a reasonably good conditions but the foundations seems to be collapsing.

Figure – 8: Pictures showing decay in the northern walls of Shalimar Garden. Photographs were taken on 08-02-2008

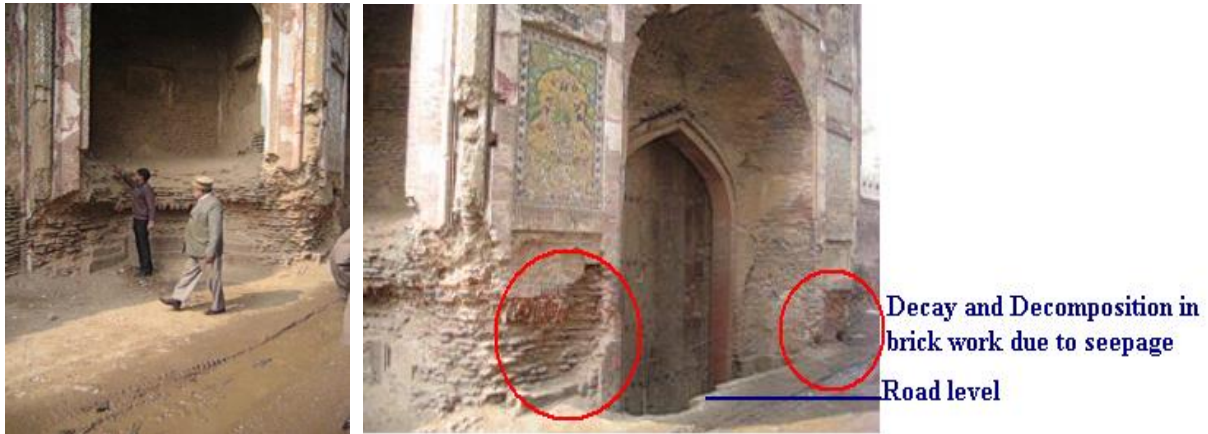
to the development process in the surroundings of the Shalimar Garden. Figure 10 shows the main gate of northern wall, which is in a miserable condition and the Ground Level of the garden, is now lower than road level and the natural ground level of the surrounding areas. Improper care and negligence in maintenance for a significantly longer time caused major deterioration in the foundations and walls of the masonry structure.

**Figure – 10: Picture showing the northern main gate of Shalimar Garden. The levels of the surrounding road is higher than the natural ground level of the garden, causing water ingress in the foundations.**

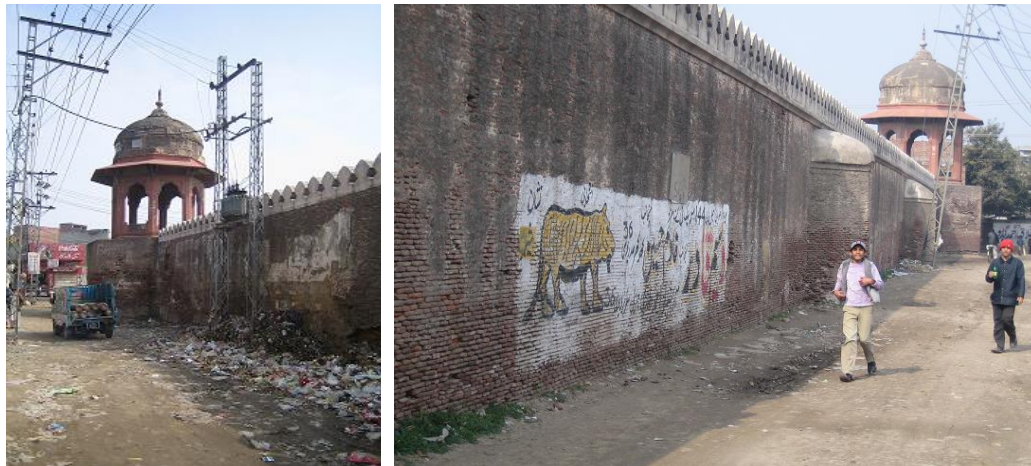
**Figure – 11: Example of poor governance by the local and city government to protect the national heritage**

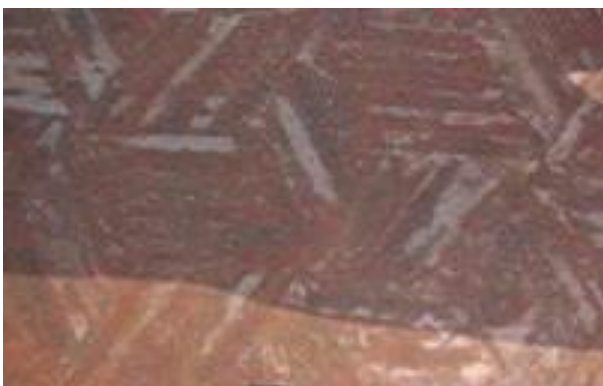
**Figure – 13: New flooring of pathways provided in gardens between 2007-08, which give a good architectural look and an esthetic match towards the Mughal architecture. Photograph was taken on 12-02-2008.**

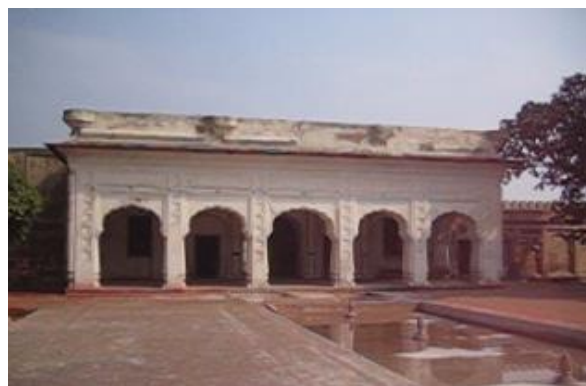
**Flooring:** The brick floors of the highest and lowest terraces were well restored under the supervision of Mr. Wali Ullah Khan and Later under Mr. Akbar Khan in the sixties and seventies. In the original design of Shalimar garden, upper and the lower terraces were subdivided by secondary water channels and narrow walkways, making sixteen plots in all (Figure 9). The source of inspiration was the Royal Paradise carpal of Shah Abbas ol Persia made in the seventeenth century for the Selari Palace at Isfahan. The red sandstone floor was replaced by the present marble floor between 1983-85.

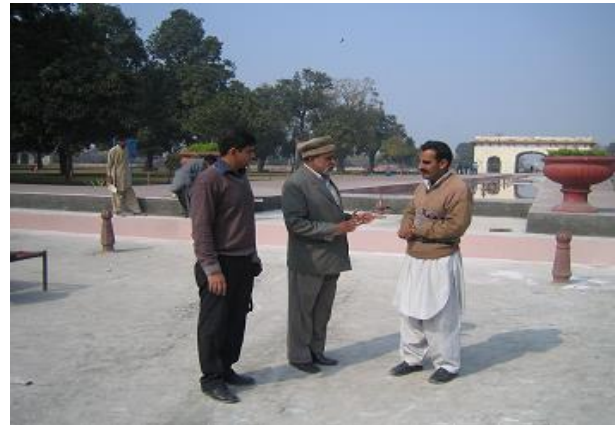
**Figure 15. Author and co-author discussing restoration methodology of Shalimar Garden with contractor's construction supervisor, in the background mason is repairing fountain side walls with ordinary black cement.**

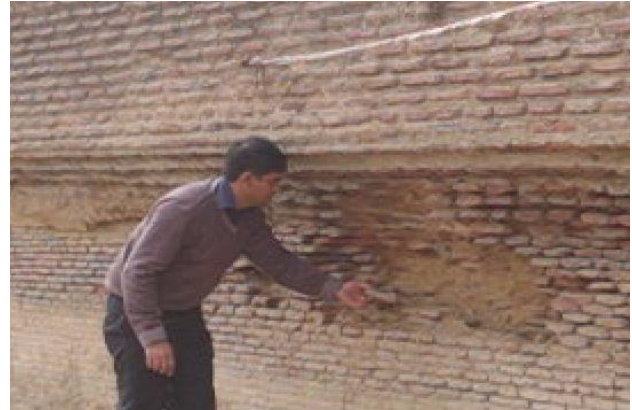
**Figure 17. Visual inspection and collection of mortar sample from outer side of northern wall of Shalimar Garden**

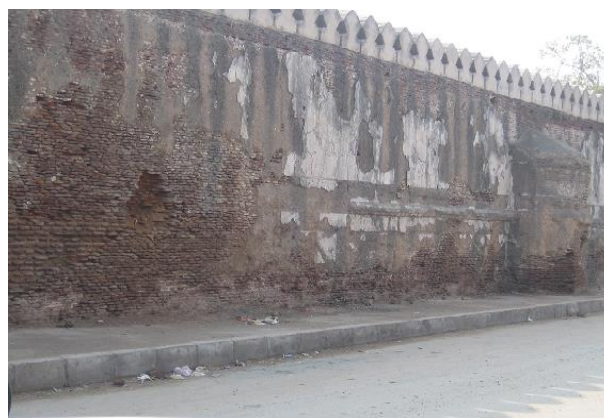
**Figure – 18:** Picture showing Eastern wall of Shalimar Garden, which shows a bad workmanship and improper restoration during maintenance of the wall in the past. Aesthetic look has not been taken into account during restoration process which gives a adverse impact to the viewers/visitors.
